| Title: | <b>Apollo Croydon 1 275kV T17 R21:<br/>Sinkhole Rehabilitation for Cluster<br/>A and stormwater management<br/>implementations</b> | Unique Identifier: | <b>LES 1770</b> |
| | | LES Project Number: | <b>LES-GP-163</b> |
| | | Documentation Type: | <b>Scope</b> |

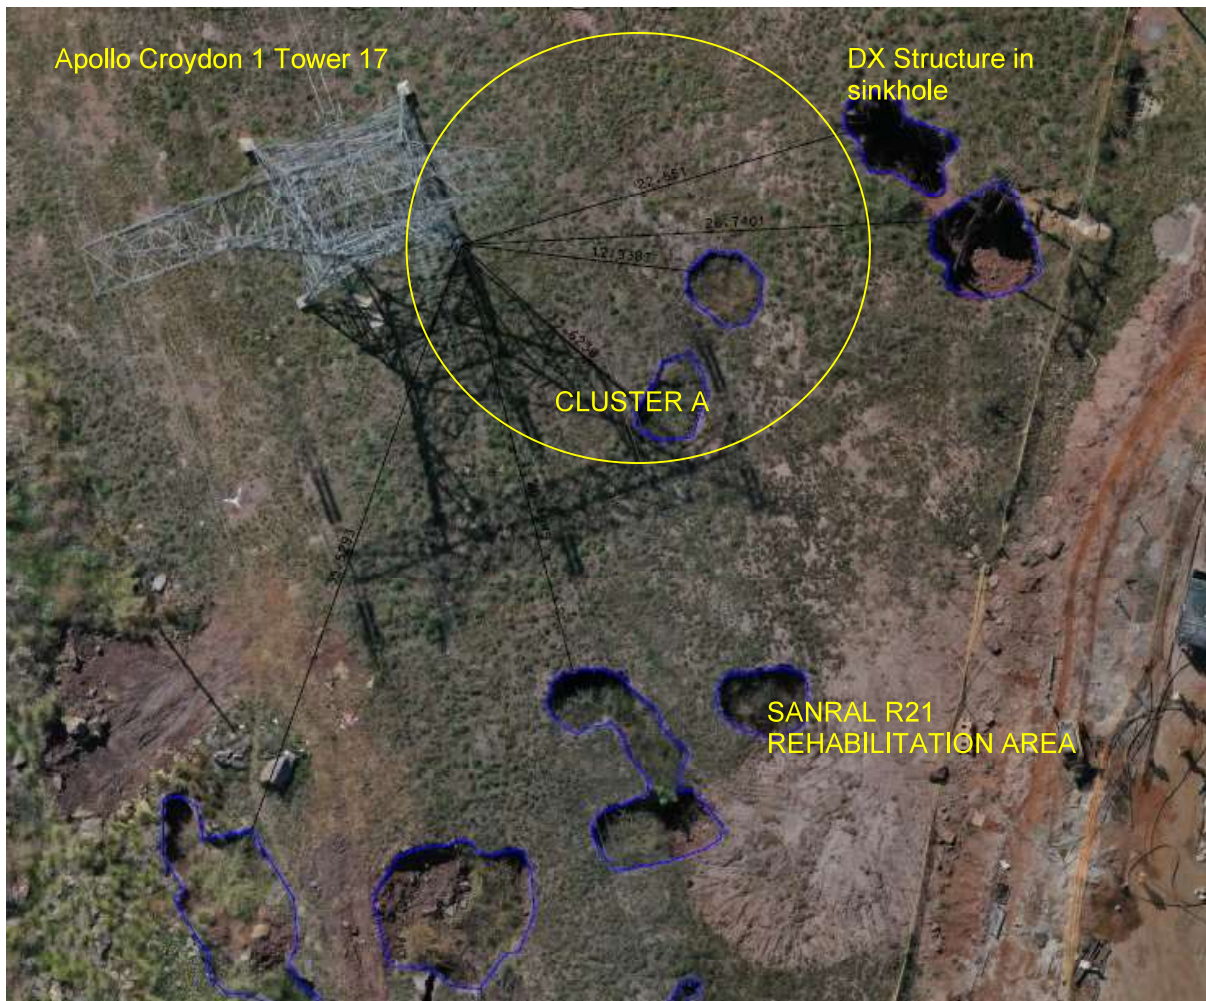
**Figure 1-1. Apollo Croydon 1 275kV T17 R21: Annotated Locality Image**

Figure 1-1 below shows an aerial image of the area taken in April 2024. Numerous sinkholes are present in the area with the closest sinkhole being noted approximately 13m from Apollo Croydon 1 275kV Tower 17, and sinkholes noted directly under from the Dx tower (i.e., Esselen – Eerstefabriekke pole 47).

This permanent solution requires the sinkhole rehabilitation for Cluster A (Refer Figure 1-1 and Figure 1-2) and the design requirements for stormwater management of the impacted servitude area. This entire document outlines the scope of *works* required.

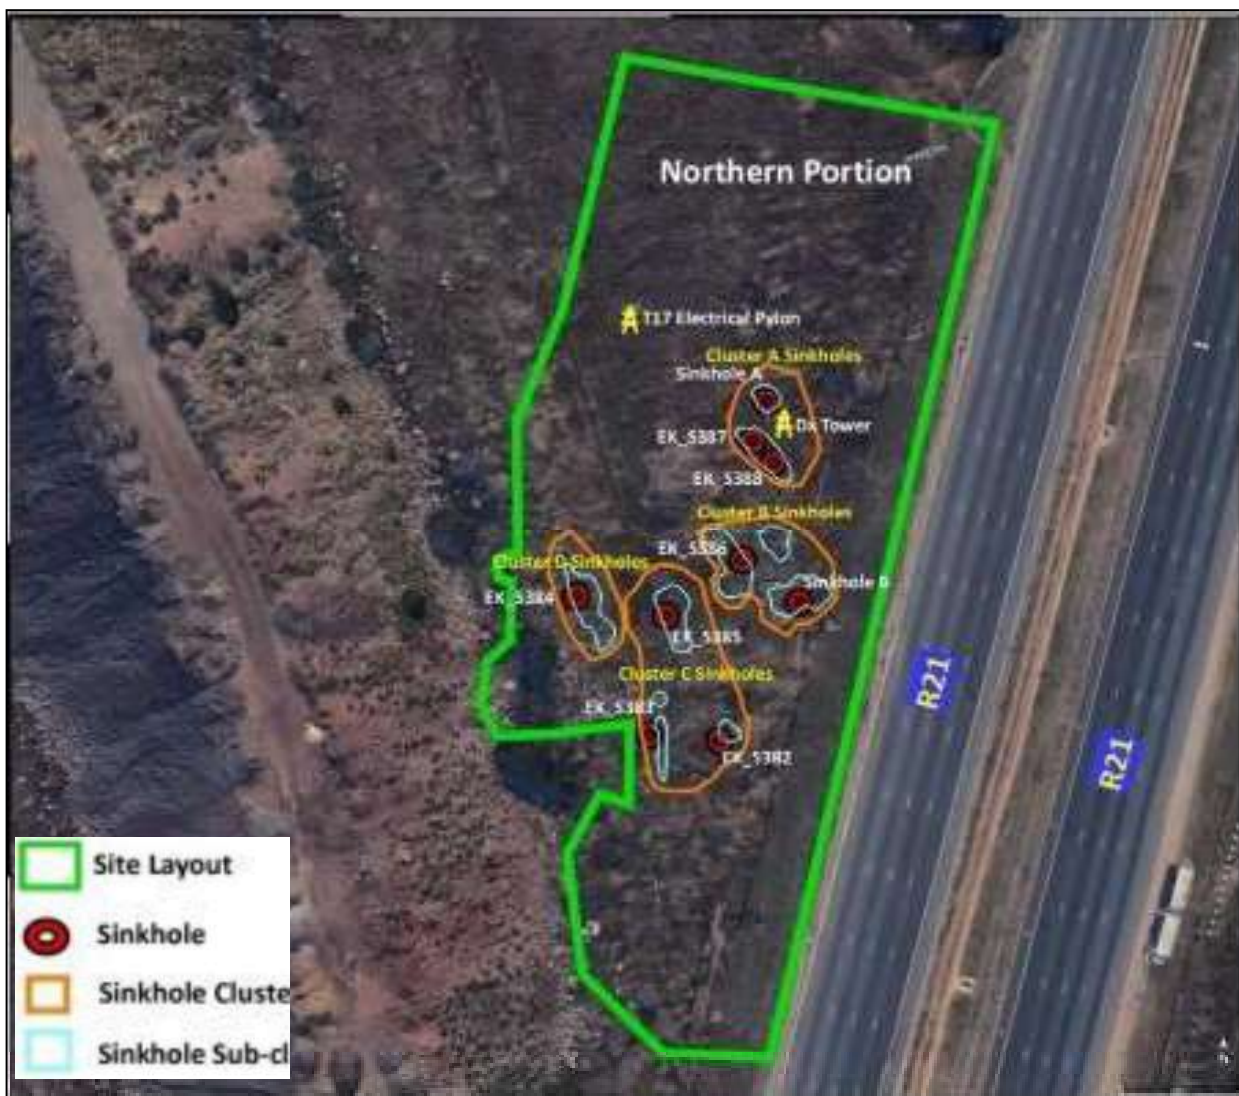
Figure 1-2. Apollo Croydon 1 275kV T17 R21: Area Layout depicting Clusters

A Dolomite Stability Investigation (DSI) was conducted in mid to late 2022 and the area was classified as D3 and D4 Dolomite Land (Refer Figure 1-3). The assessment further classified the area into four (4) clusters (Refer Figure 1-2).

- a) Cluster A has been identified as the group of sinkholes closest to the NTCSA Tx and Eskom Dx infrastructure (Refer Figure 1-2 and Figure 1-2 above).
- b) The *Contractor* appoints a Dolomite Land Level 3 Specialist to ensure successful implementation of the works in the area.
- c) The *Contractor* will review all technical documentation submitted in the receivables pack.
- d) At onset of works, the *Contractor* conducts a visual assessment of the area to determine areas of alignment of the current area conditions with the provided DSI report.
