# OR TAMBO TERMINAL A REFURBISHMENT Stage 3 – Design Report

**Structural, Mechanical, Electrical,  
ICT and Fire Services**

Document Reference Number: 60476403-01-0000-M-J-003-R

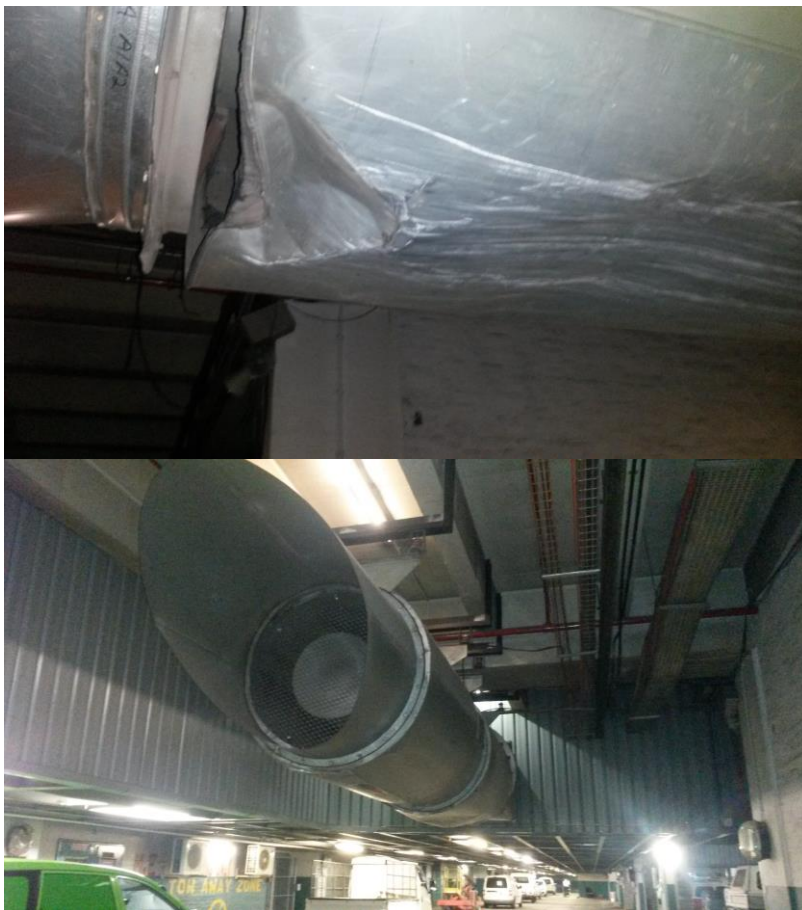
Figure 2: The damaged ducting of the large exhaust fan

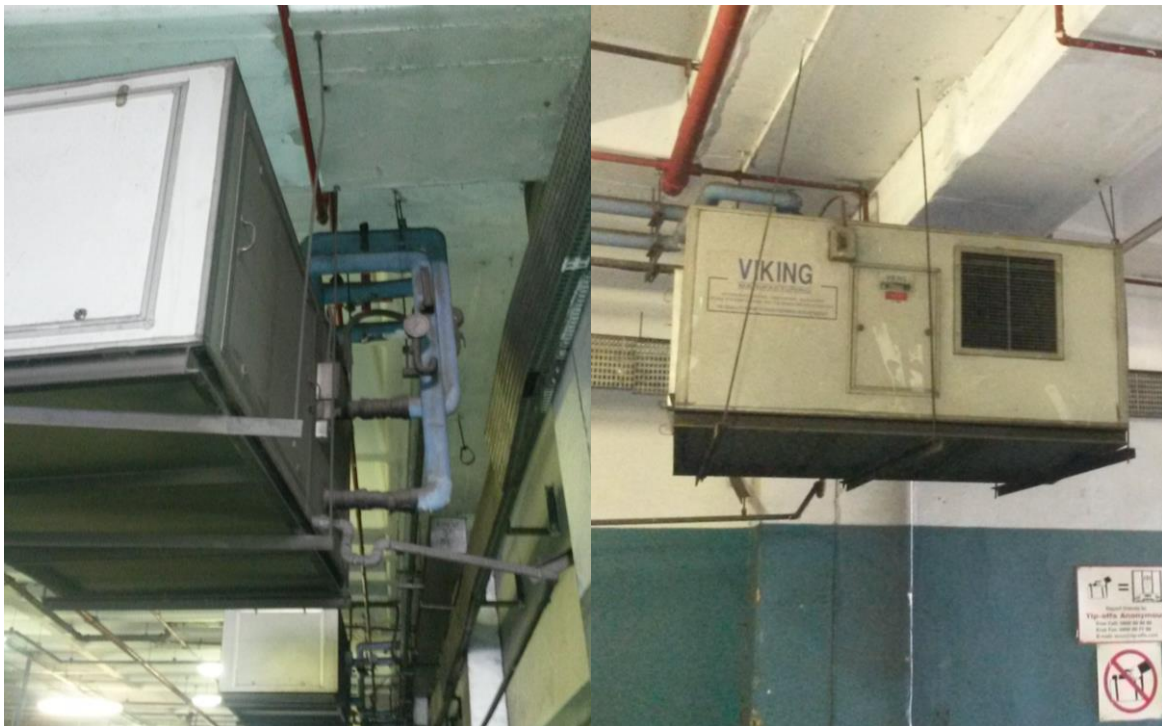
**Figure 3: Un-ducted FCU suspended from the ceiling slab in the Baggage Handling area of the basement**

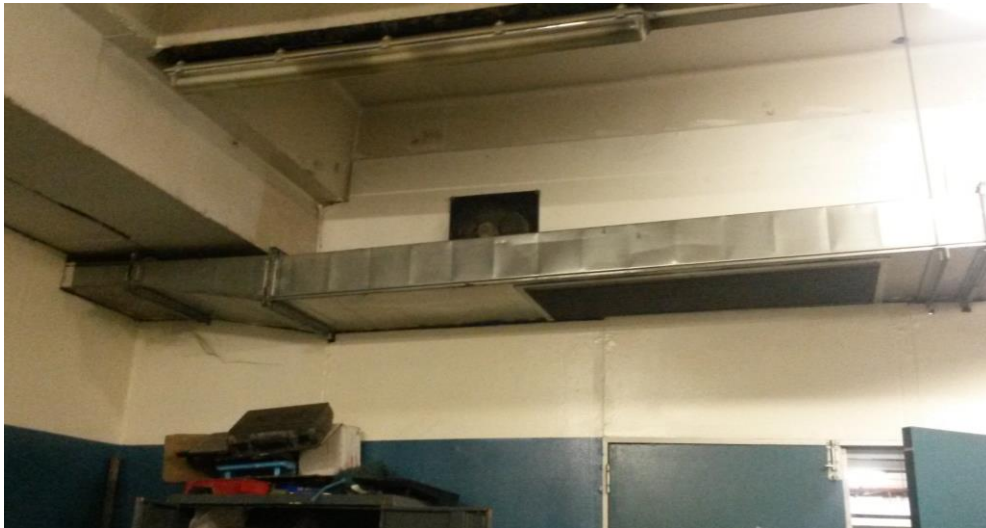
**Figure 5: Crisplant Mechanical Workshop - the small wall mounted fan semi blocked by the passing duct**

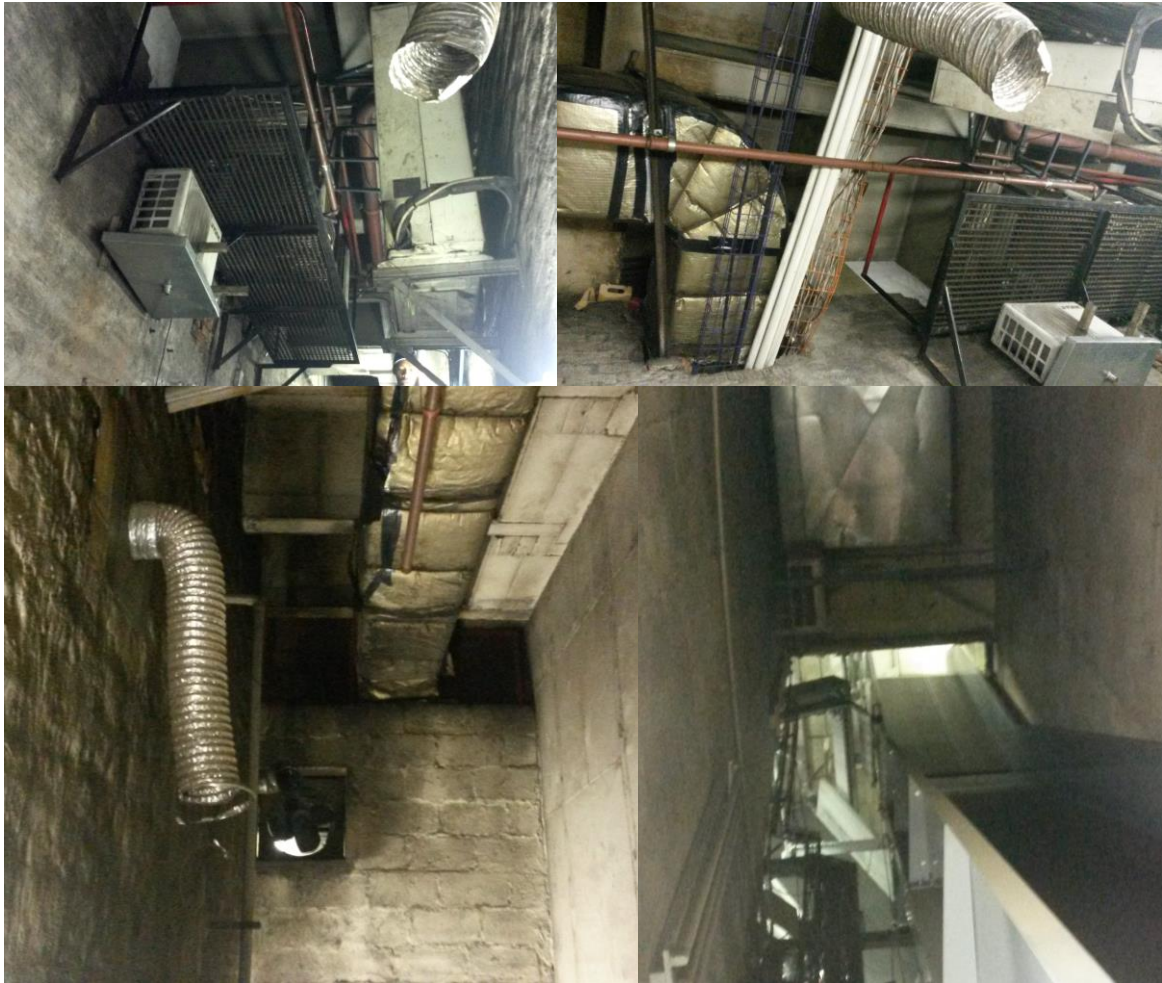
**Figure 6: Baggage carousels connecting level shafts - all HVAC equipment not in use anymore**

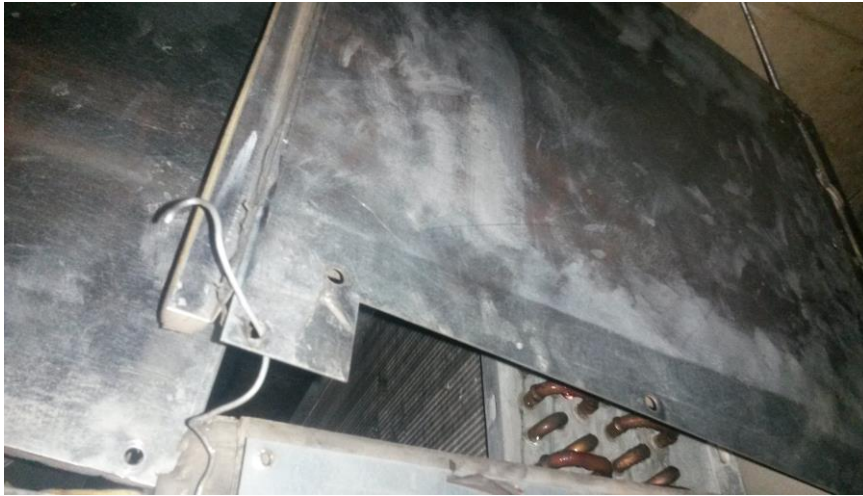
Figure 8: Kenya Airways Offices – FCU missing panel bolts

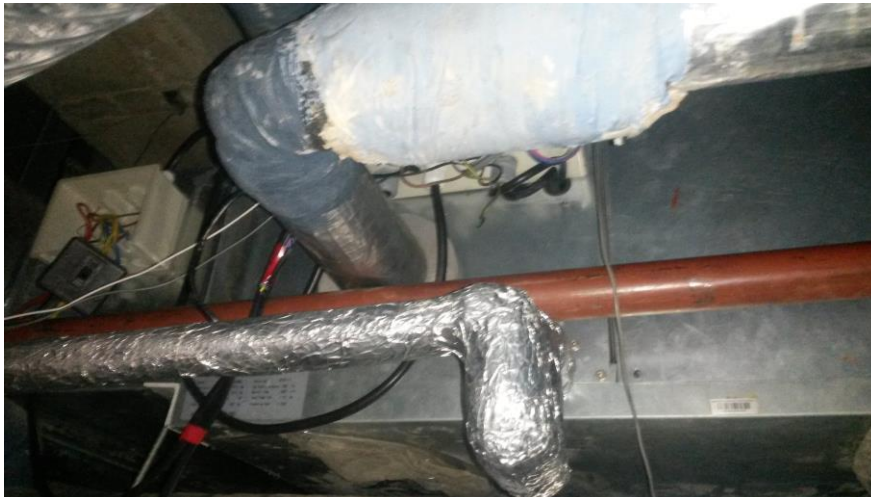
Figure 9: Kenya Airways Offices – FCU Chilled Water pipping and Electrical Wiring condition

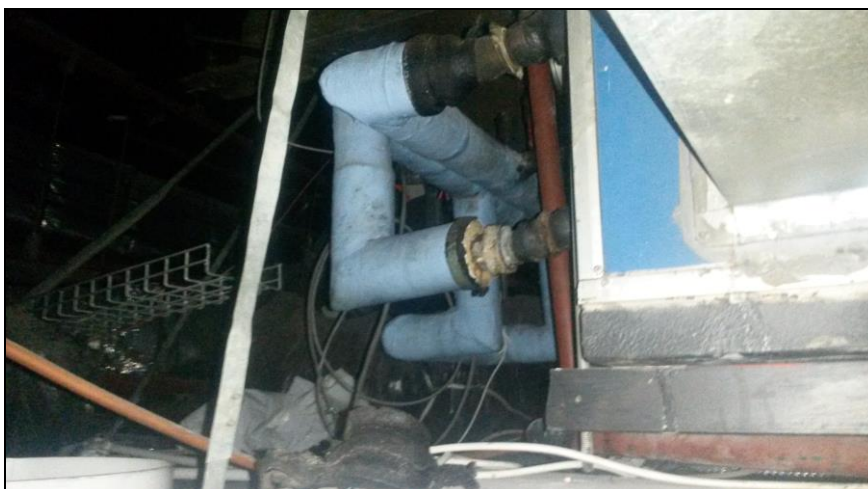
Figure 10: UTS Store Room - FCU Chilled Water pipping condition

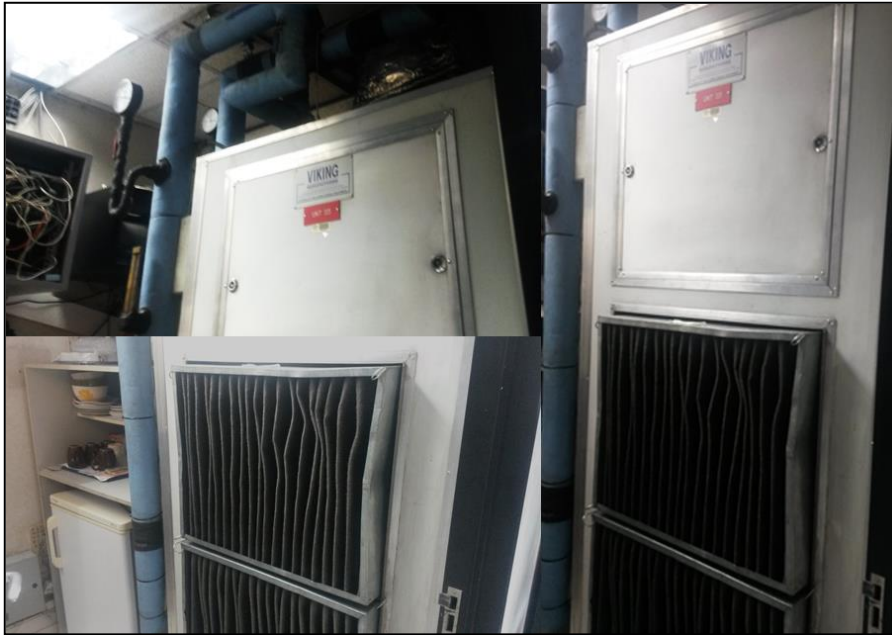
**Figure 11: TAAG Offices - AHU 115 in same space as occupants' kitchen area**

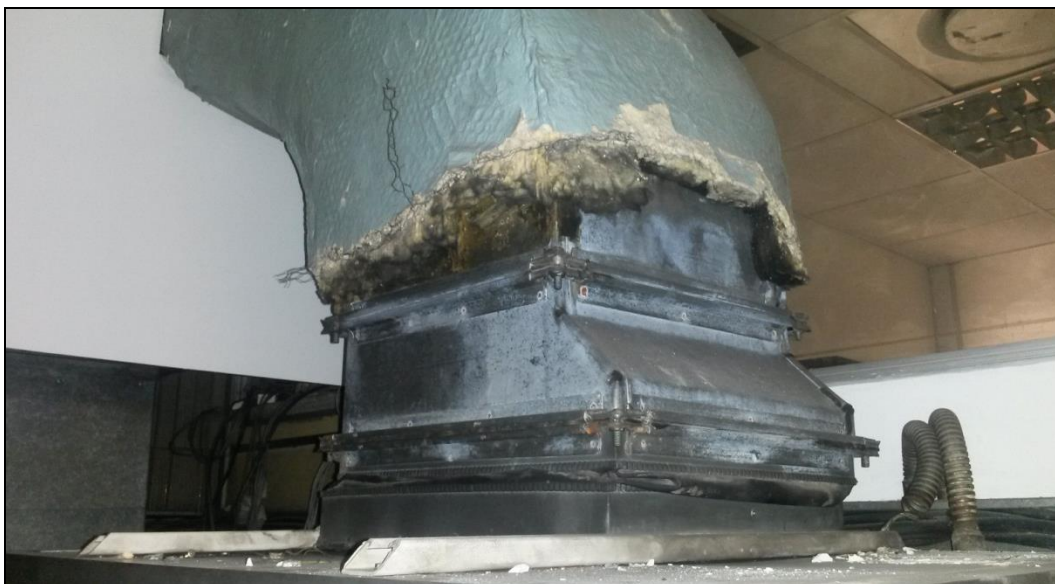
**Figure 12: FCU xx (GL 33-34 & I-J) in office room acting as plantroom**

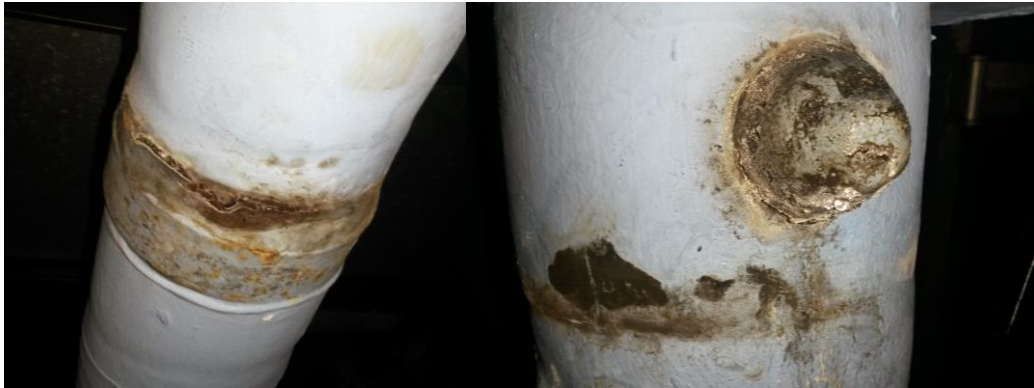
**Figure 13: Damaged chilled water piping insulation as for Plantroom 7 units**

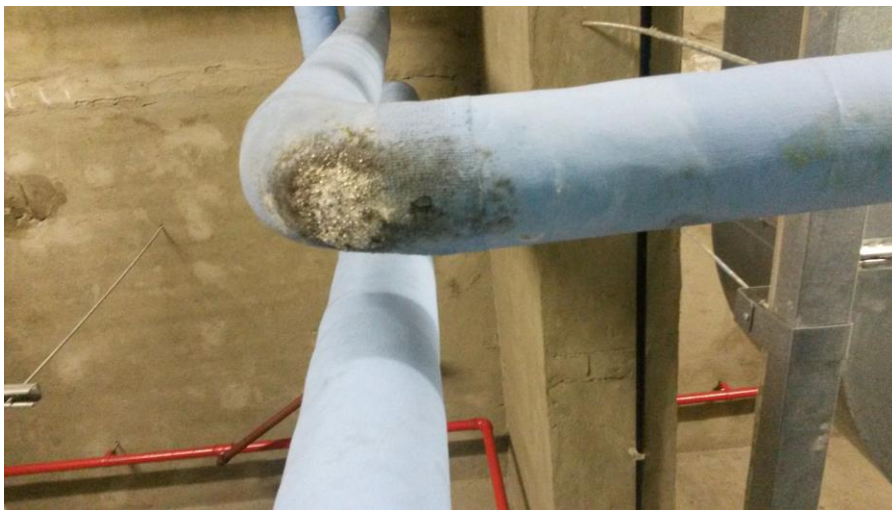
**Figure 14: Damaged chilled water piping insulation for Plantroom 8 units**

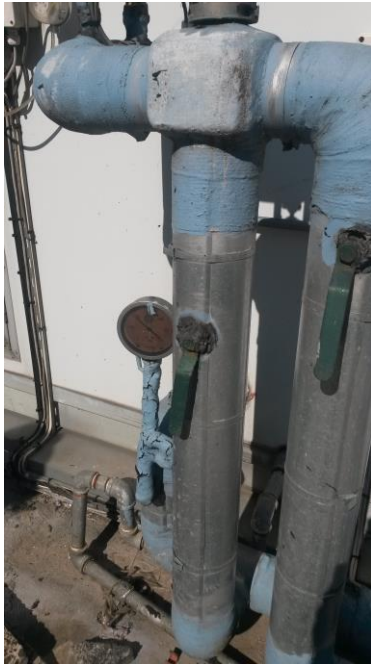
Figure 15: Example of Chilled Water Piping condition of AHU 121

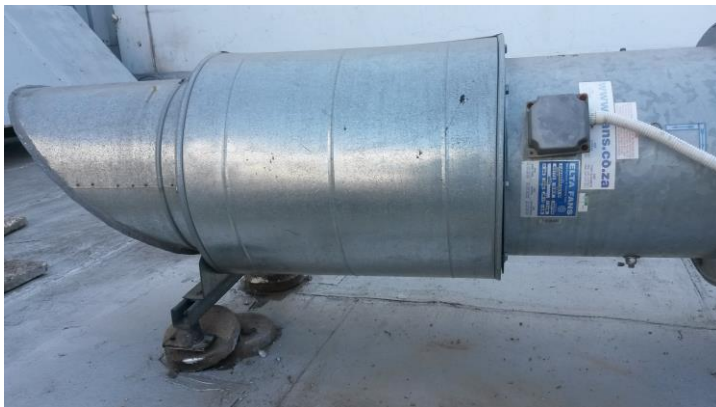
Figure 17: Toilet Exhaust Fan - Leg support of fan

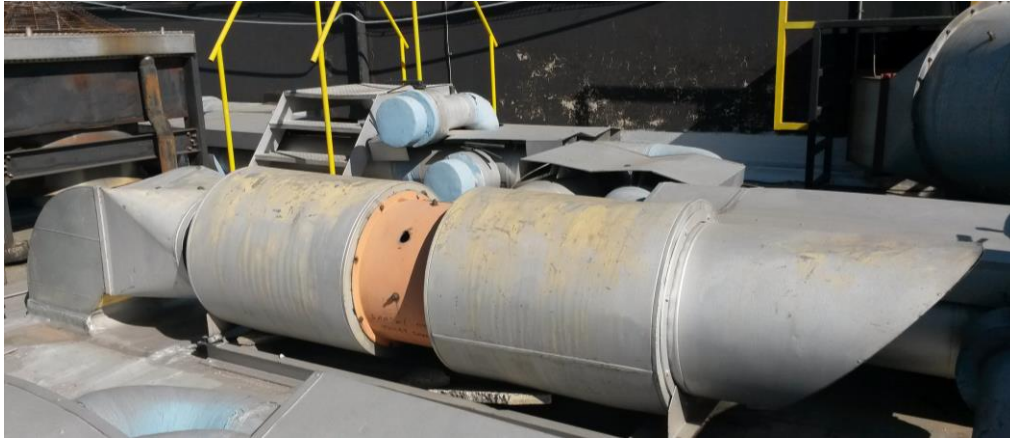
**Figure 18: Toilet Exhaust Fan - Ducting dented**

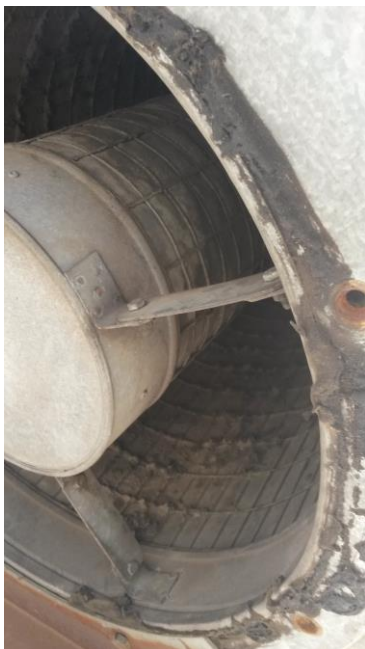
**Figure 20: Toilet Exhaust Fan with no mesh at exhaust air exit**

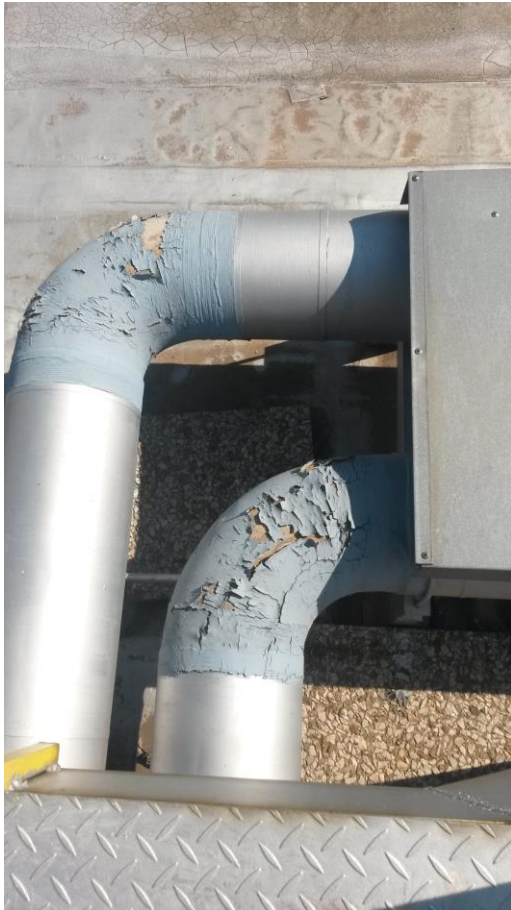
**Figure 21: Example of Chilled Water Piping insulation cracked at an elbow bend**

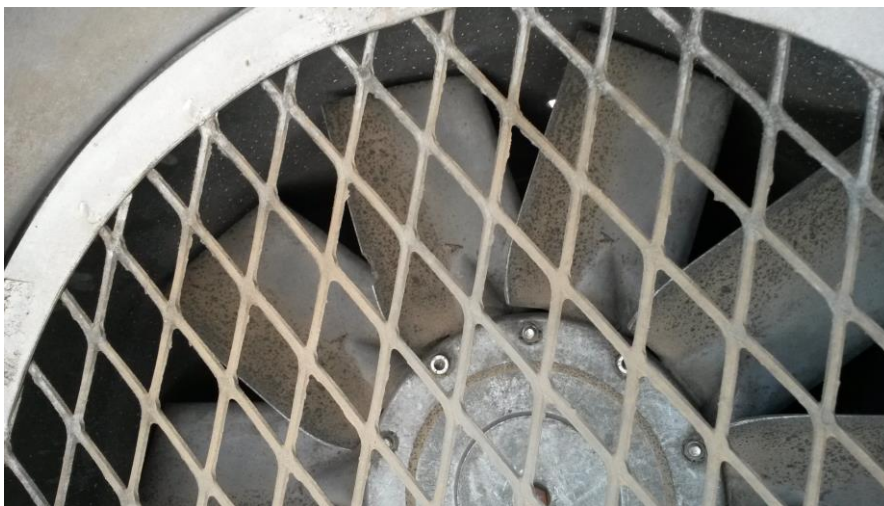
**Figure 22: Toilet Exhaust Fan - example of blade condition**

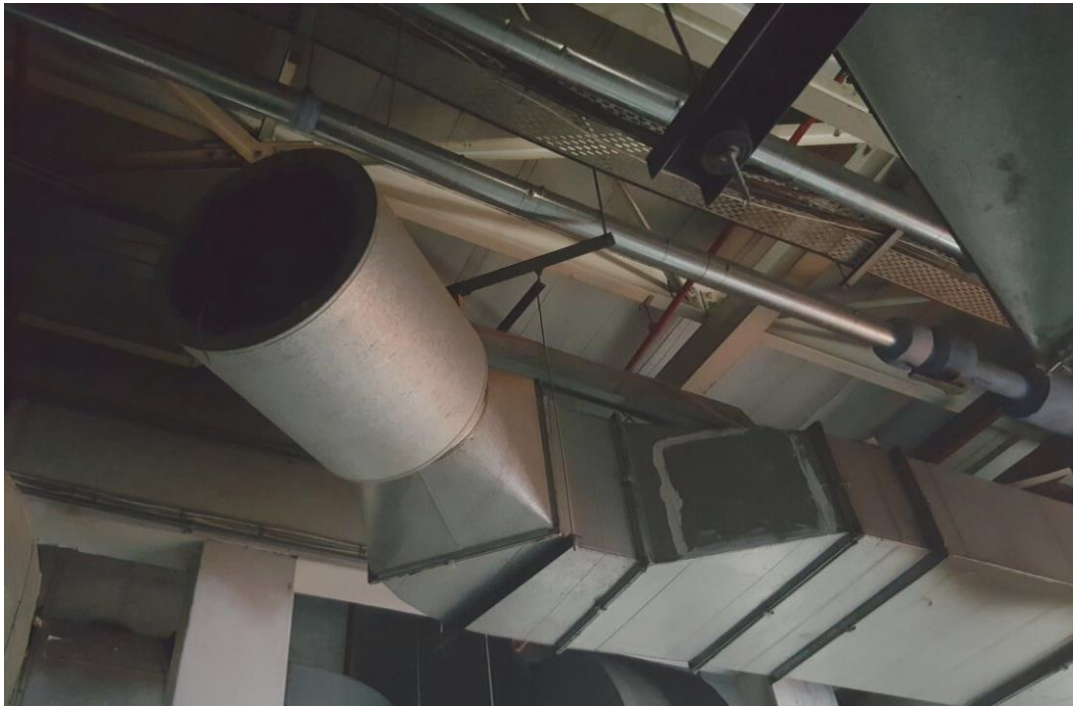
**Figure 24: Toilet Exhaust duct with no fan in Plantroom 2**
