**WEST BANK LAND RESTITUTION TOWNSHIP:  
DISTRIBUTOR ROAD & SEWER PIPELINE  
GEOTECHNICAL REPORT**

**FEBRUARY 2006**

**LUKHOZI CONSULTING ENGINEERS (PTY) LTD**  
PO Box 19204  
Tecoma  
5214

**TERRECO**  
PO Box 1007  
Gonubie  
5256  
Tel 043 7211502

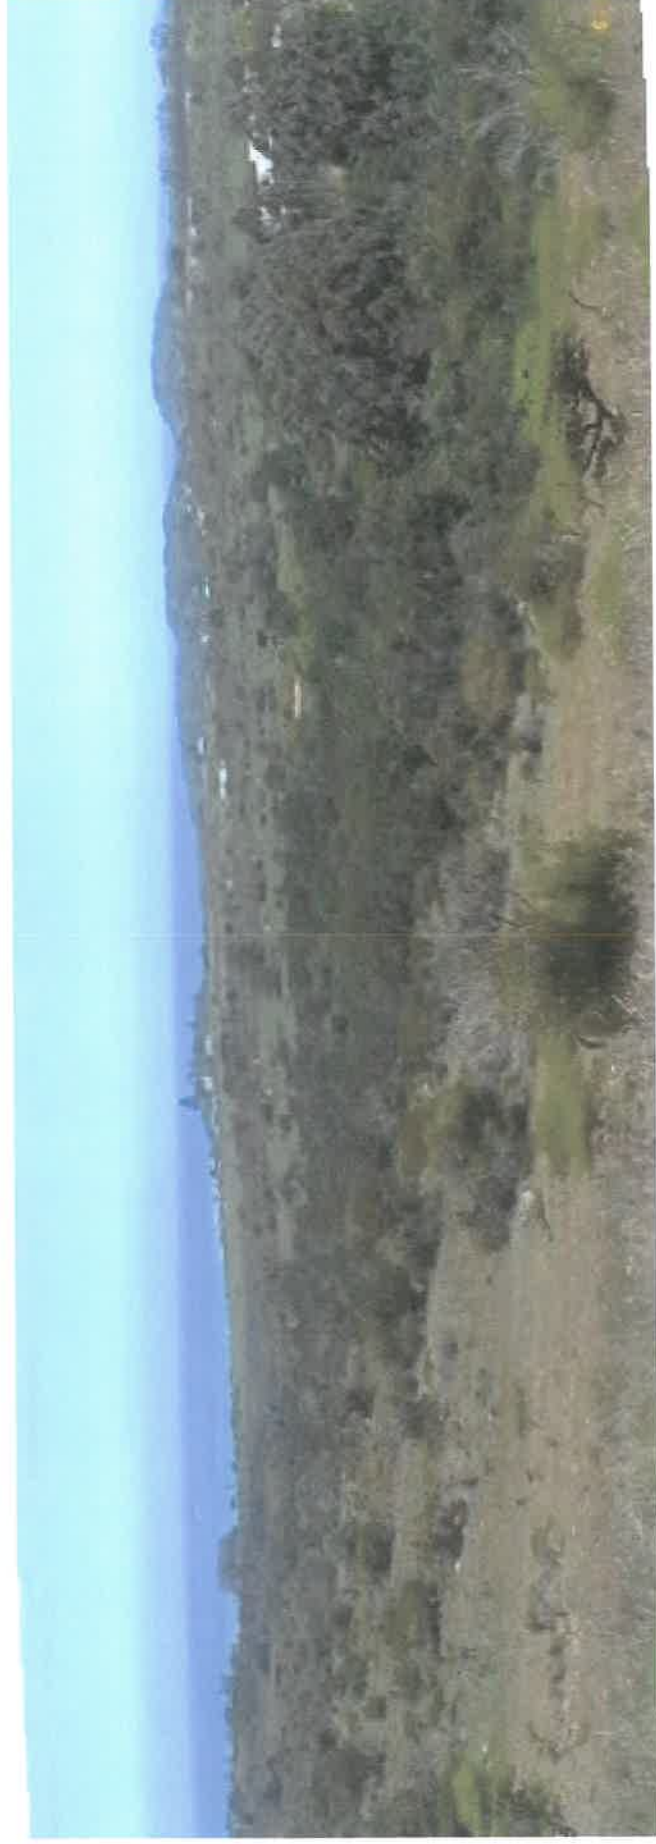
***Plate 1: Seaward view of the West Bank Restitution Farm area***

The distributor road and sewer pipeline are located on rolling hill type topography with relatively flat hilltops separated by narrow tree and bush covered valleys. The western area comprises a natural plain and contains an uninhabited farmhouse. Small thorn trees and grass vegetation dominate the landscape and an old borrow pit is located along the proposed road's centreline. Plate 1 over page provides a panorama of the site as viewed seawards from the north-eastern corner of the farm.

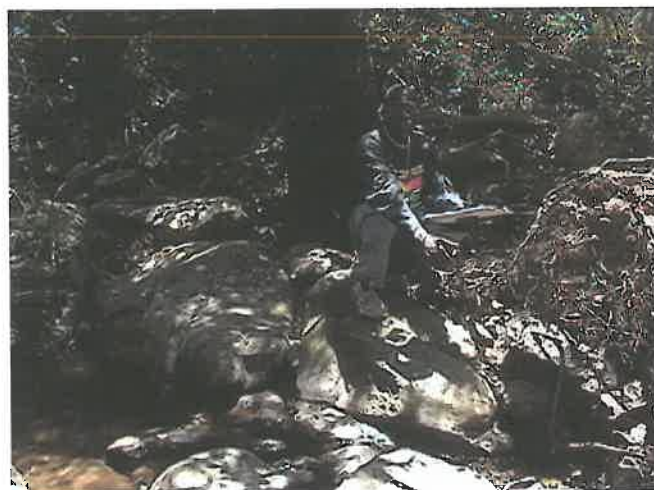
Safe allowable bearing capacity of the sandstone is expected to exceed 3500kPa. Plate 13 below indicates the good quality sandstone for bridge founding in the stream section of the road.

**Plate 13: Stream foundation rock**

The 30m wide alluvial section demarcating the stream line and environs comprises approximately 1m of silty sand alluvium overlying 0,3 – 0,8m of silt cobbles and boulders; in turn overlying slightly weathered to unweathered, closely jointed, hard rock sandstone. The 5m wide stream channel has massive sandstone outcrop exposures with quality of rock more than capable as founding for the bridge structure. The stream is expected to have meandered across this alluvial area but the nature of the rock exposure, namely sandstone, and the near-horizontal dip of strata, makes it unlikely that alluvium is much deeper than the approximate 2m indicated in Trial holes 4R and 5R.

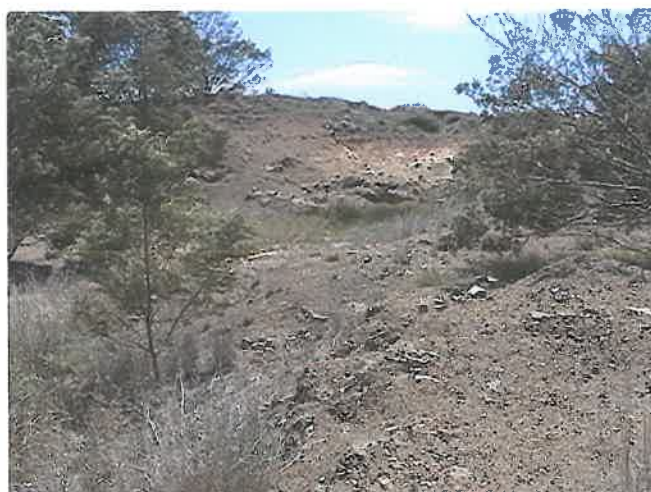
Field investigations and laboratory testing suggest that the borrow pit at Trial Hole 2R could possibly be reopened as a source of road material (see Plate 14).

**Plate 14: Mudstone borrow pit**

This material might ravel and corrugate when used as a gravel wearing course yet is capable of providing a reasonably good surface and being hard, is likely to last. As G6 quality it would also serve as selected subgrade in a surfaced road pavement. The highly weathered mudstone and sandstone do not have appeal as gravel wearing course for reasons as previously listed.

The weathered mudstone in the borrow pit is, however, hard, and will require large, and possibly specialised, construction plant for its excavation. There is already a large pit from which material was previously excavated so there is no doubt excavation is possible. Experience suggests, however, that contractors are loathe to commit machinery to hard excavation and such reluctance should therefore be expected during construction. Shallow blasting with single stage crushing may be considered since it would provide a superior quality gravel wearing course and omit contractual problems with hard excavation. It will cost more.
